# Hangover for catalytic converters

A long-term road trial with six cars revealed that the admixture of (bio-)ethanol to gasoline makes the catalytic converter age faster. The catalytic converter of a gasoline-driven car retrofitted for biogas didn't even last 40,000 kilometers. Overall, the catalytic converters did, however, prove to be surprisingly robust in the practical trial.

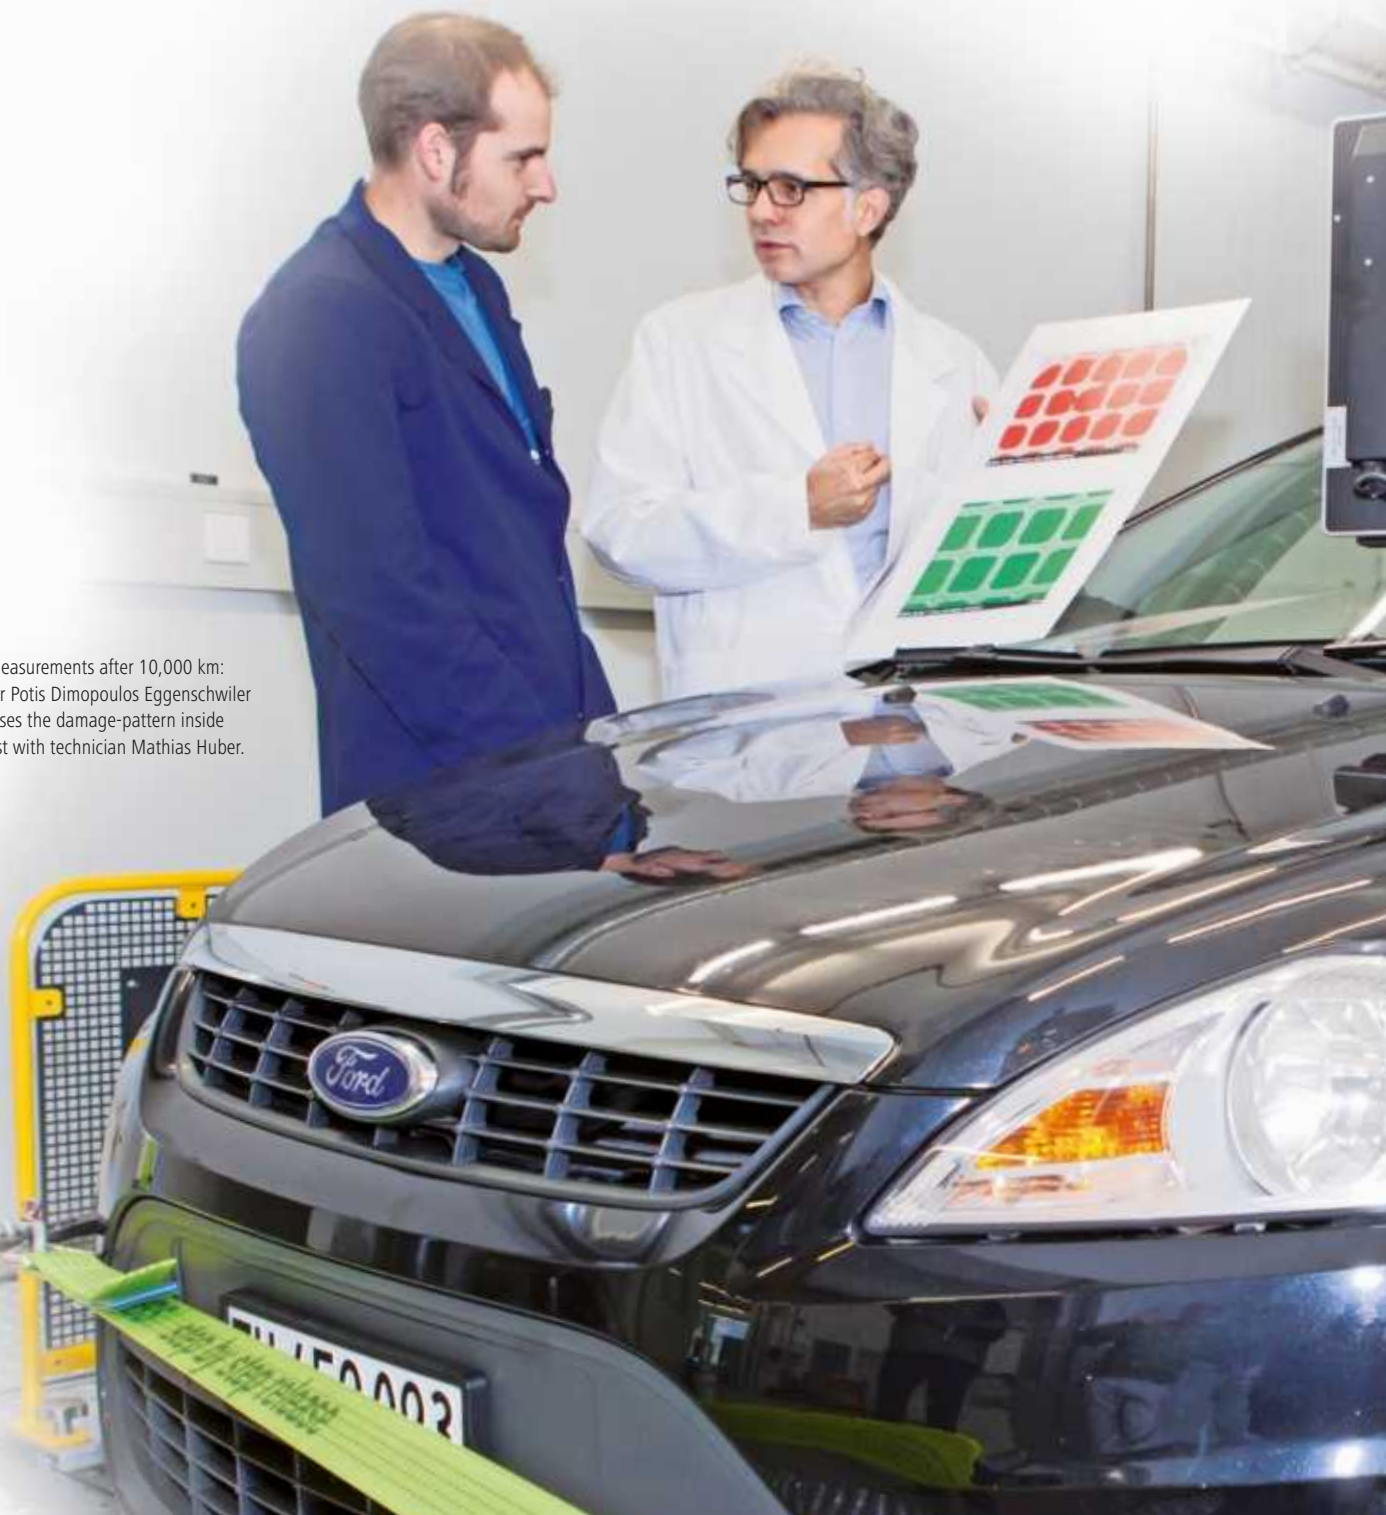
Test bench measurements after 10,000 km: project leader Potis Dimopoulos Eggenschwiler (right) discusses the damage-pattern inside of the catalyst with technician Mathias Huber.
